TALLINN UNIVERSITY OF TECHNOLOGY  
SCHOOL OF ENGINEERING  
Department of Civil Engineering and Architecture

# **VISUAL ASSESSMENT OF STIFFNESS-AFFECTING CHARACTERISTICS OF RECLAIMED STRUCTURAL TIMBER**

MASTER THESIS

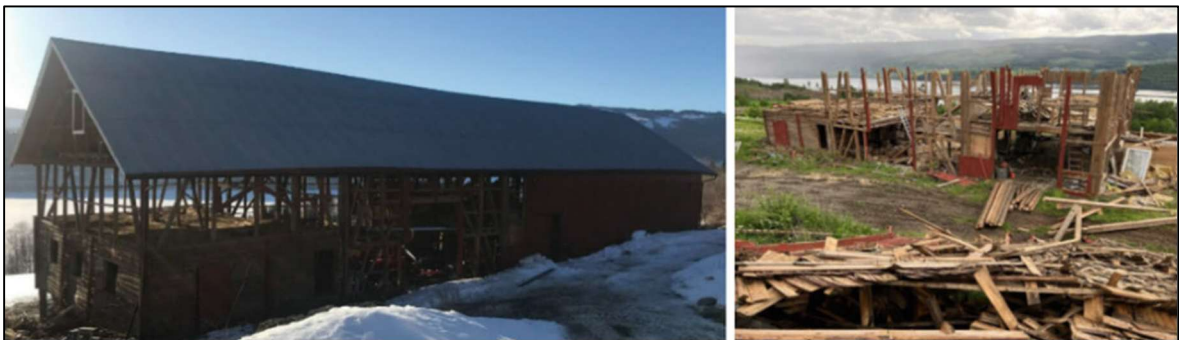
Photo 3.1-1 Barn structure in Brøttum, Ringsaker and its dismantling process [13]

The barn, constructed in the late nineteenth century, was a timber-framed structure, and the recovered elements are assumed to have served as load-bearing components within the building. Following dismantling, the timber was collected, cleaned from metal fasteners and prepared for further investigation. Due to the nature of the reclamation process, the exact original position and structural role of individual elements within the building are not fully known. [13]

The material investigated in this study consists of reclaimed structural timber originating from a dismantled timber barn. The timber samples were supplied by the Norwegian company Omtre AS and were sourced from a traditional Norwegian barn structure located in Brøttum, Ringsaker (Photo 3.1-1). The investigated timber consisted of Norway spruce (*Picea abies*) [13]

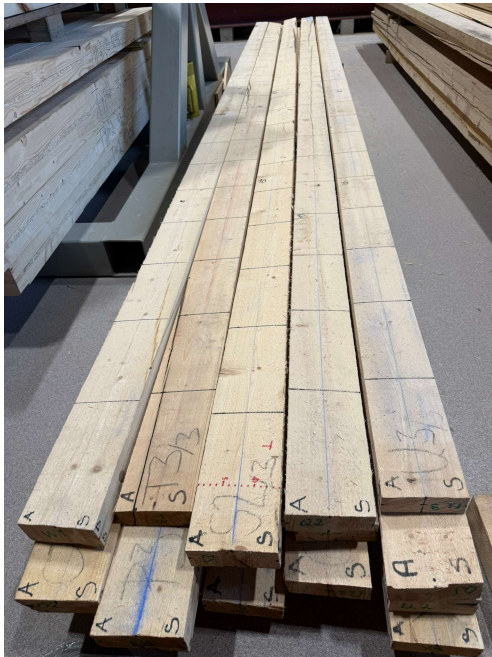
Photo 3.2-1 Reclaimed timber beams used in the study prior to testing

The investigated specimens and their preparation prior to testing are shown in Photos 3.2-1 and 3.2-2. Visual defects were identified, documented and marked prior to testing,

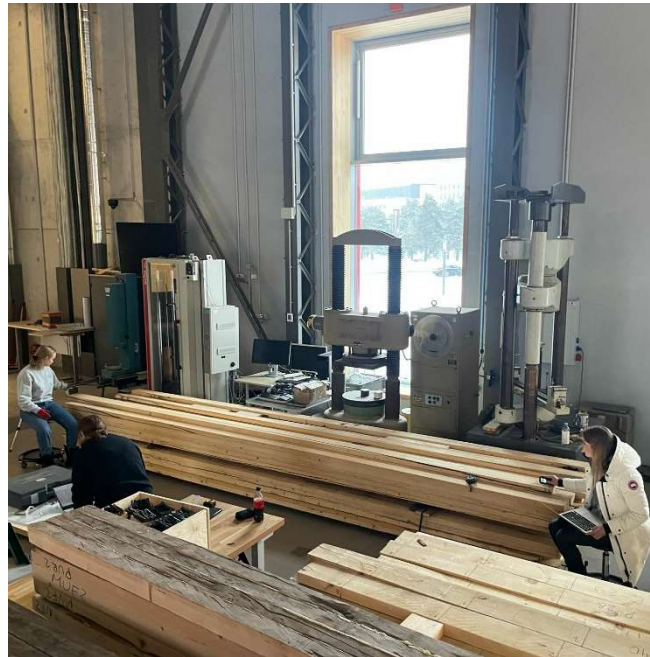
Photo 3.2-2 Measurement of specimen geometry and documentation of visual defects
